# **Idaho National Laboratory Quarterly Performance Analysis**

2<sup>nd</sup> Quarter FY 2014

## INL/EXT-14-32137

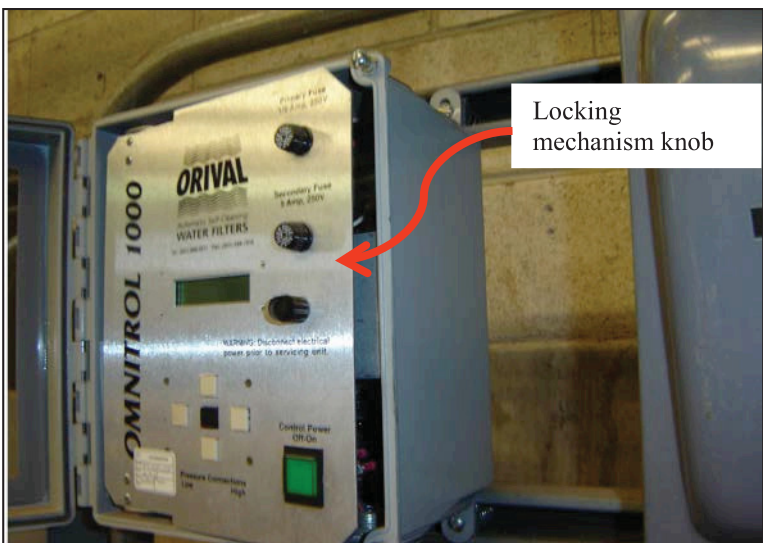
The Ops Specs access this panel once a day during daily rounds and press the face buttons to determine if the filters needed to be flushed. The display panel is attached to the panel box with a plastic knob with a locking lobe on one side to secure the panel to the box. When the Ops Specs push the control buttons daily, the locking knob worked itself down, unlocking the panel.

The Ops Specs stated that they have seen the panel slightly opened once or twice over the past year, but with their training, they felt comfortable to close the panel and re-secure the knob. They recognized that it was not a normal

condition. The Ops Spec that performed the rounds the previous night, stated that the display panel was closed.

What can we learn? Over time the locking mechanism had become weakened to the point that when taking readings, the knob would rotate on its own and the door would come open. Operators did not recognize this as an abnormal condition or recognize that their “higher than normal electrical risk” qualification did not allow them to take the actions that they had been taking.

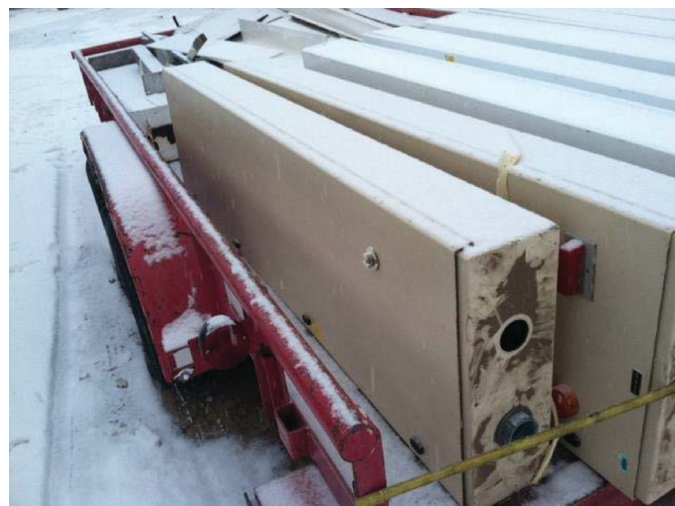
An employee was working with three others to move a Special Nuclear Material detector out of Building MFC-719.

During this work evolution, the employee's left index finger was pinched/smashed between the detector and his steel-toed boot. The laceration required two stitches.

As the workers pushed to slide/rotate the detector, it either caught on the bottom and tipped or the top of the detector was pushed with enough force to tip it over and pinch the workers finger between it and his boot. Personnel must place emphasis on the importance of situational awareness (such as where am I, and what are the potential hazards) and also on good communications in order to prevent such occurrences.
